1. Report No.	2. Government Accession No.	3. Recipients's Catalog No.	
4. Title and Subtitle  Inspection and Testing of Low Speed Vehicles		5. Report Date August 1998

6. Performing Organization Code NRD-23	
7. Author(s) Jeff Elias		8. Performing Organization Report No. VRTC-83-0461	
9. Performing Organization Name and Address National Highway Traffic Safety Administration Vehicle Research and Test Center P.O. Box 37 East Liberty, OH 43319		10. Work Unit No. (TRAI5)n code

14. Sponsoring Agency Code	
15. Supplementary Notes			
<p>16. Abstract</p> <p>In response to petitions by the golf cart industry the National Highway Traffic Safety Administration reviewed its position on low speed vehicles and has taken steps to define a new class of low speed vehicle (LSV) which is exempt from the federal motor vehicle safety standards (FMVSS) that apply to motor vehicles. A new safety standard, FMVSS 100, has been proposed to regulate this new class of vehicle.</p> <p>The Vehicle Research and Test Center conducted a survey and a series of tests to evaluate the safety and stability of LSVs. Two neighborhood electric vehicles, the Bombardier and the GEM, and one golf car, the Yamaha gasoline pow

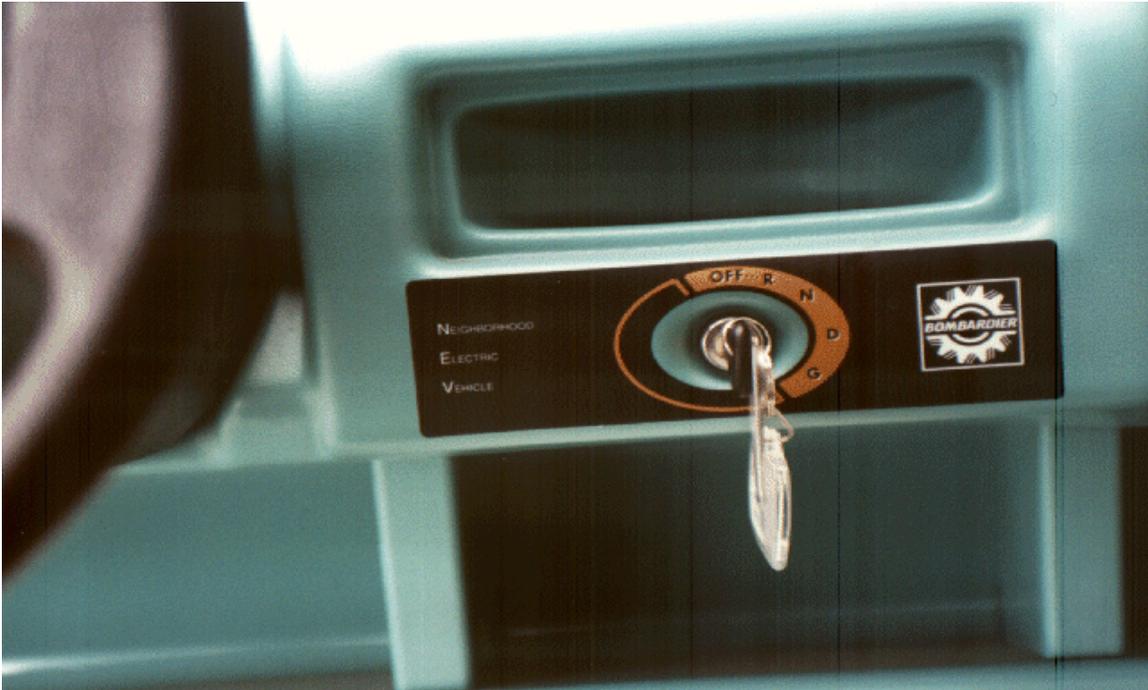
Figure 6 - Keyed Transmission Selector (Bombardier)

The vehicle used a keyed system to operate the transmission selection. Figure 6 is a photograph of the ignition/transmission lock. The labeled positions were OFF (in the upright or 12:00 position) with R, N, D and G spaced clockwise around the lock. This information (transmission selection) was repeated on the instrument display panel as seen in Figure 7.

When the key was turned to the R (reverse) position, a loud piercing audible backup signal was activated. Turning the key to the N (neutral) position allowed the operator to activate the various electronics of the vehicle such as the charge level gauge, horn, lights, etc. without allowing the vehicle to move when the foot throttle was depressed. Selecting the D position allowed the vehicle to operate at its maximum design speed while selecting the G position limited the top speed of the vehicle to less than 15 mph.

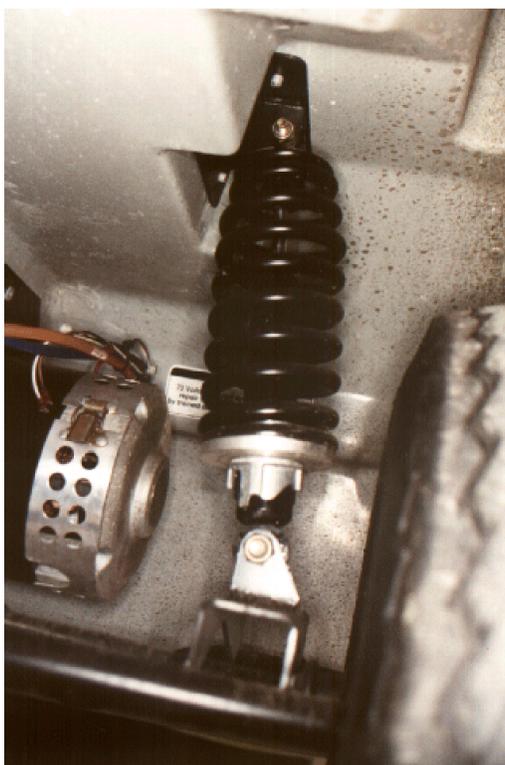
Figure 8 - Right Rear Suspension

The vehicle was equipped with a four wheel single A-arm independent suspension system. Each wheel had a coil spring with a shock absorber running up the center of the spring ( Figure 8). There was an adjustment system located at the base of each coil spring (Figure 9). The adjustment system was a stepped ratchet that compresses the coil spring by up to three increments, thereby increasing the force of the spring element of the suspension system.

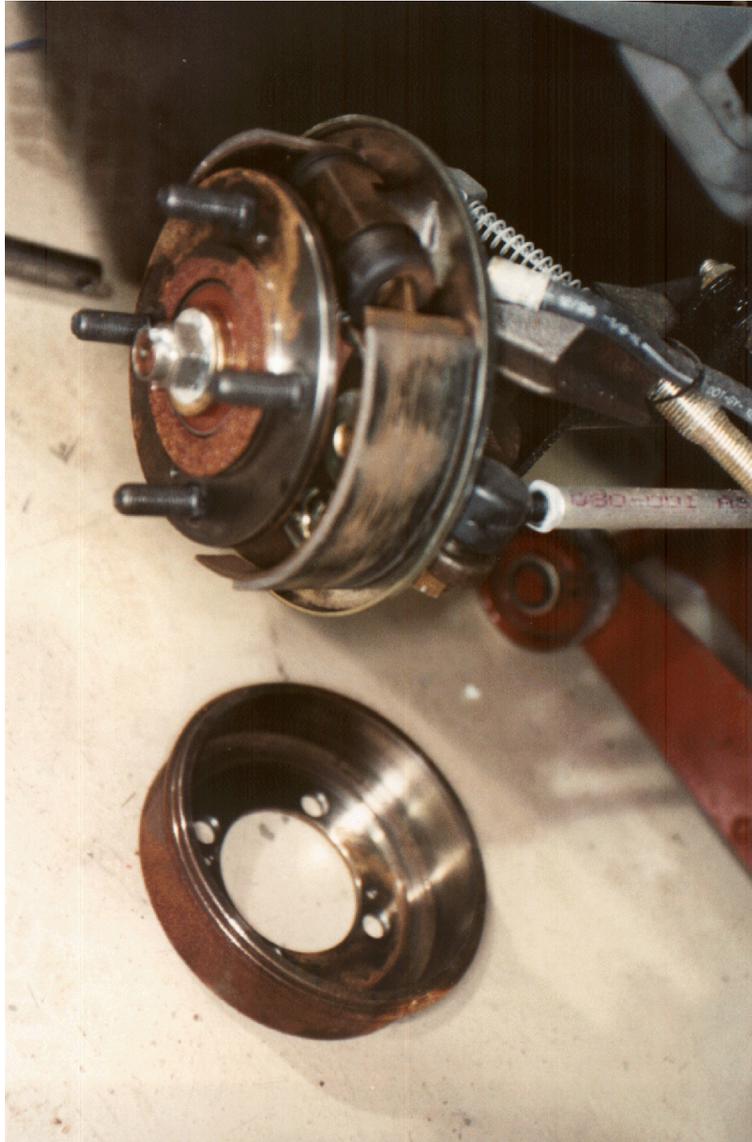
Figure 10 - Details of Drum, Brake Pads, and Wheel Cylinder

The Bombardier had hydraulic drum brakes for the front wheels. There was no power assistance for the system. The diameter of the drum was measured to be 6.25 inches. There was no adjustment mechanism to take up slack in the brake system as the pads begin to wear. Figure 10 is a photograph showing the drum, pads, and control lines to the system.

As can be seen in Figure 10 the parking brake is a mechanical/cable system. The parking brake was a center mounted, hand activated lever mounted between the two seats. The lever had a ratchet set mechanism with a thumb activated release button located on the end of the handle. The system is similar to that of many passenger vehicles with a hand activated parking brake located in the same position. As noted previously, the instrument panel had a warning light to indicate when the parking brake is activated.

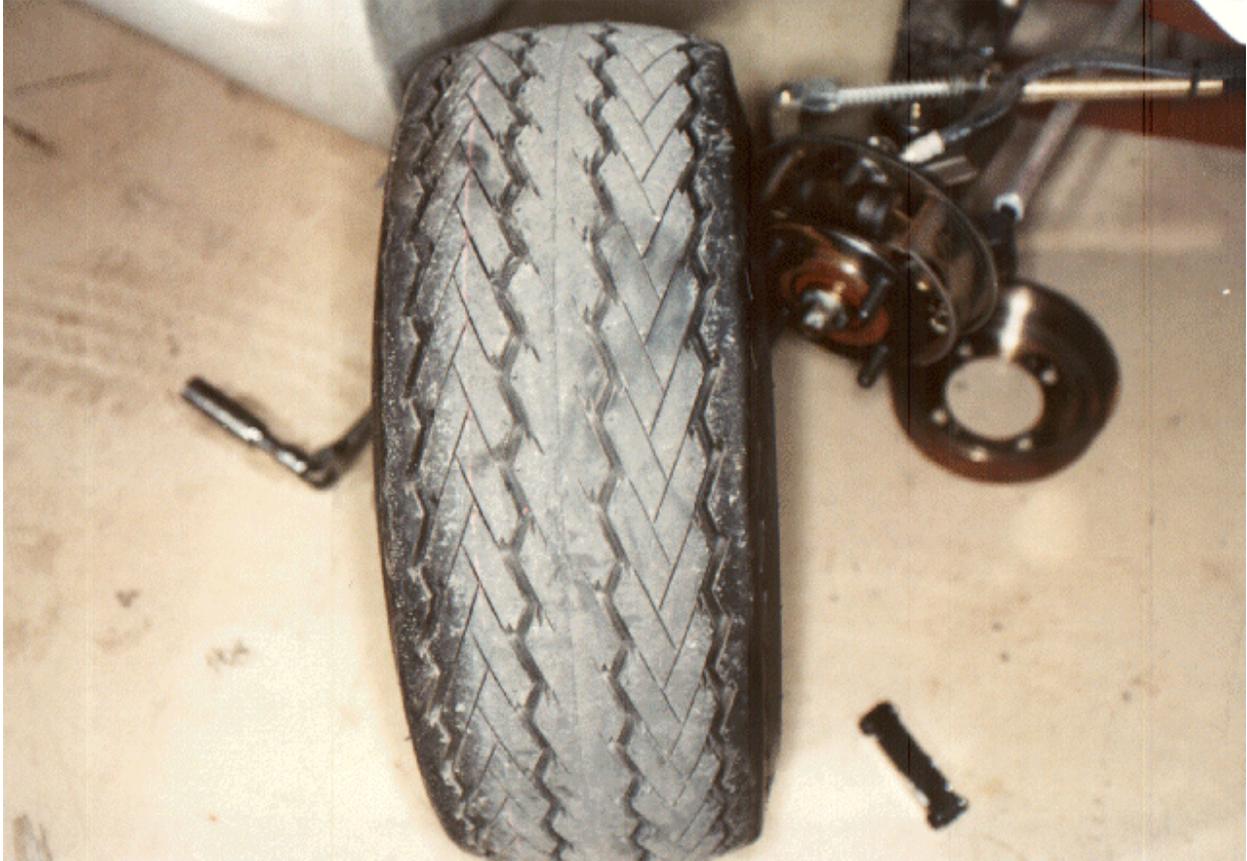
Figure 11 - Front Right "Turf" Style Tire

The tires on this vehicle were a quality high speed trailer tire with a road tread (See Figure 11). Markings on the tire side wall indicated that it was a 10 inch diameter tire (20.5 x 8 - 10<sup>o</sup> 76M 00871).

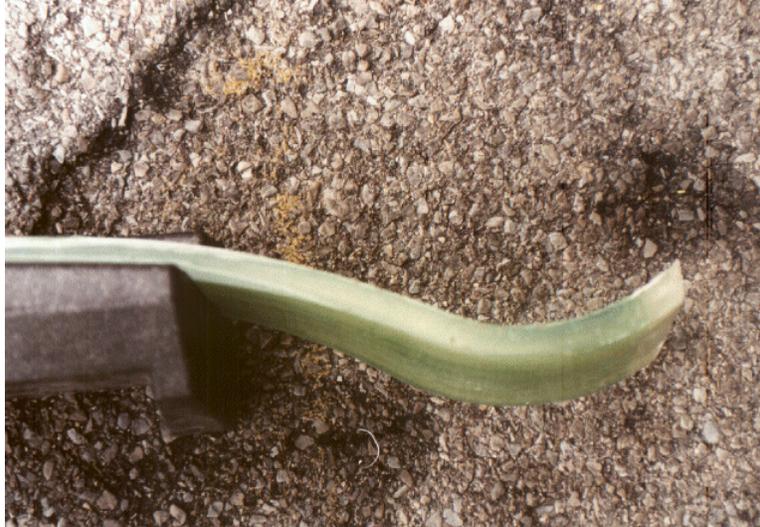
Figure 13 - Details of Bumper

The bumpers of the vehicle had a very light and flexible cosmetic cover. Beneath the cover was a block of closed cell foam (similar to Styrofoam) backed with a long polymer/fiberglass flat spring structure (see Figures 12 and 13). The rear bumper attached directly to the differential. The rack and pinion gearing was located directly behind the front bumper attachment (See Figure 14).

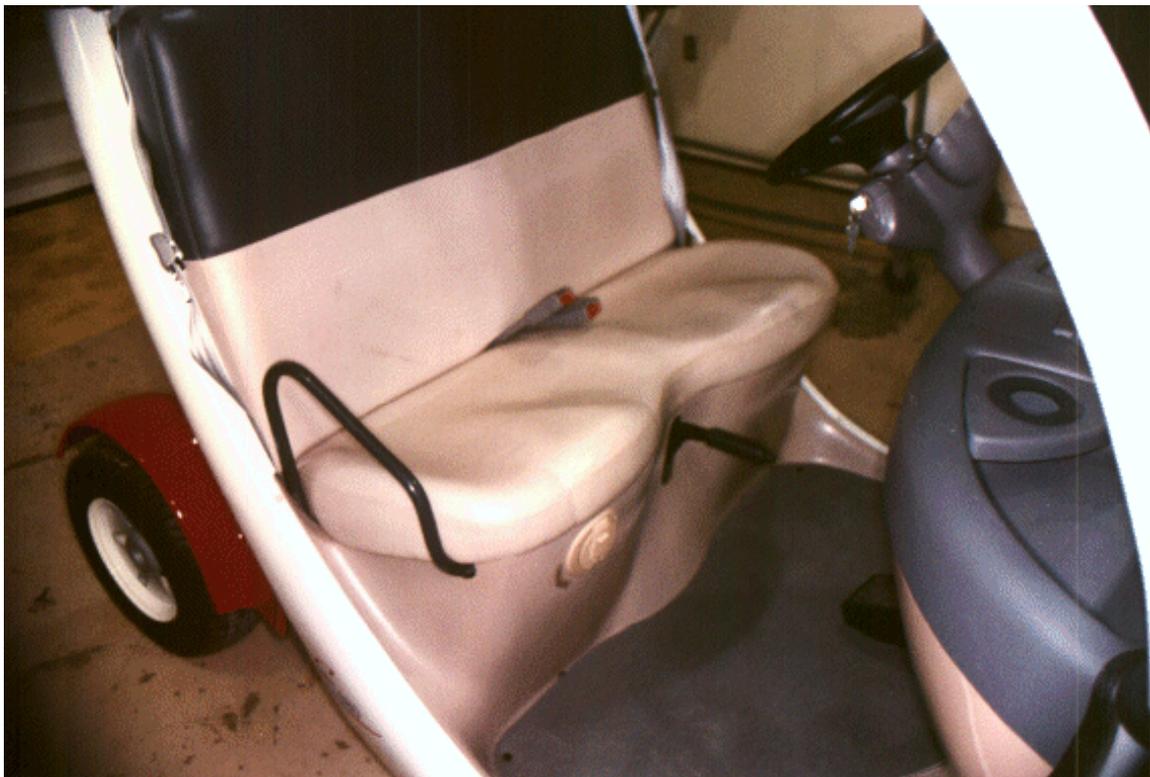
Figure 18 - GEM Bench Seating

The seat of the GEM was a padded bench type seat similar to the bench seat of a typical golf cart. Figure 18 is a photograph of the seating arrangements which shows the molded bench seat. The seat was molded in such a manner as to suggest/limit the occupancy to two. The bench was attached to the seat pan with a series of small Velcro tabs (approximately 1 inch in diameter) located around the rim of the pan and the bottom of the bench. The seat pan and bench had a definite angle that dropped from front to back. The forward height of the pan was approximately 24 ¼ inches from the ground while the rear of the seat dropped approximately 2 inches (22 ¼ inches from the ground). The padding on the bench was approximately 4 inches thick making the seat height measurements approximately 28 ¼ inches high for the front of the seat and 26 ¼ inches high for the back.

The brake system used a combination of stainless steel tubing and flexible hose to route the lines to the individual tires. The parking brake was a mechanical/cable system which engaged the rear wheels. The parking brake was engaged by a hand lever located in the face of the seat pan between the driver and passenger seating positions (See Figure 18).

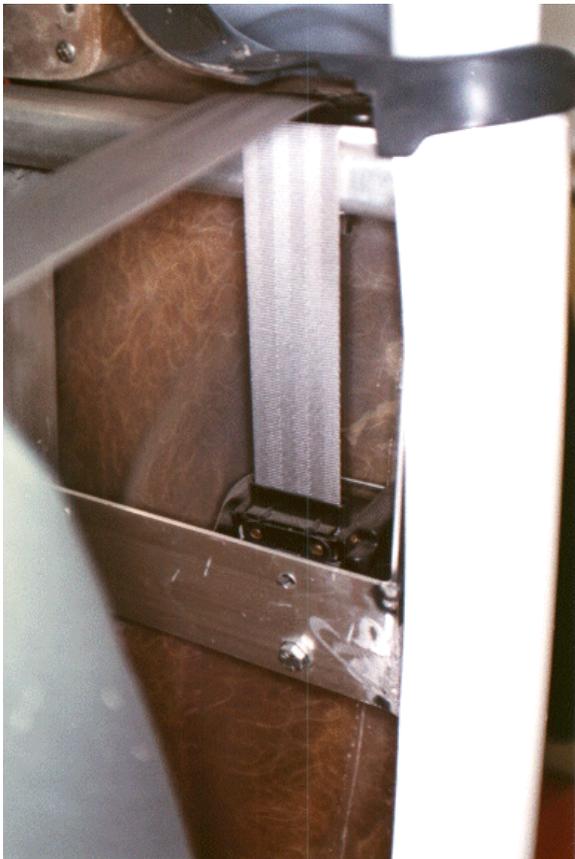
Figure 19 - Seat Belt Anchor for Reel and D-Ring Mount

framework behind the seatback which formed part of the cross-bracing of the vehicle. Figure 19 is a photograph showing the mounting of the upper end of the restraint system. The belt threaded through a D-ring bolted to the frame of the vehicle at the height of the seat back. This D-ring had no height adjustment capabilities. The buckle of the restraint system, shown in Figure 20, was mounted on a short

stalk that bolted directly to the framework behind the seatback. The anchor points for both the upper and lower portions of the seat restraint appeared to be located at structurally secure points on the frame of the vehicle.

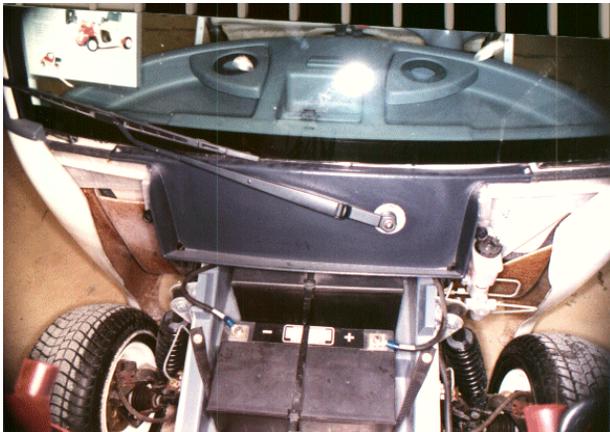
Figure 21 - Two Batteries in Forward Compartment

The GEM used a 48 volt electric motor to drive the front wheels of the vehicle. Two 12 volt lead/acid maintenance free batteries were mounted in the floor pan area beneath the seat with 2 additional batteries mounted above the electric motor in a compartment forward of the passenger compartment. Figure 21 is a photograph showing the position of the two forward batteries. The second battery was located directly behind the one visible in the picture (essentially beneath the dash of the passenger compartment). Figure 22 shows the two batteries located beneath the bench seat of the vehicle. As can be seen in these photographs, the removable bench seat was all that separated the passenger compartment batteries from the occupants. The two batteries that were located in the forward position were isolated from the occupants by the fiberglass shell of the body of the vehicle. All of the batteries appeared to be mounted to their trays with a heavy ½ inch plastic tie strap. There was no gasket or containment shell in the battery compartment beneath the seat.

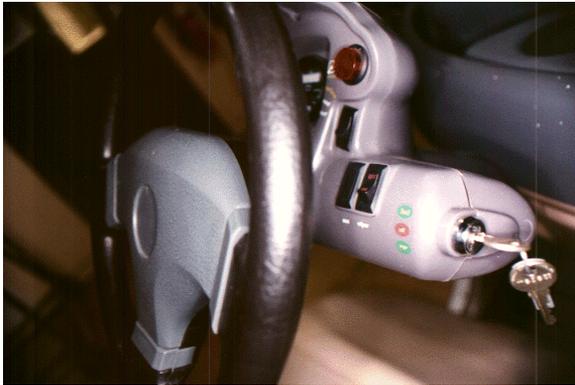
Figure 23 - Vehicle Controls - Right Side

The vehicle used a keyed system to operate the transmission selection. Figure 23 is a photograph showing the details of the ignition/transmission selection. There were three keyed positions labeled OFF, FORWARD, and REVERSE. When the key was turned to the REVERSE position, there was an audible warning beep. When the key was turned to start, there was an audible warning beep if the charging cable was plugged into the charging outlet or if the hand operated parking brake was engaged. Figure 24 is a photograph of the left side control features. The stalk was the turn signal lever and the red button located in front of the stalk activated the horn.

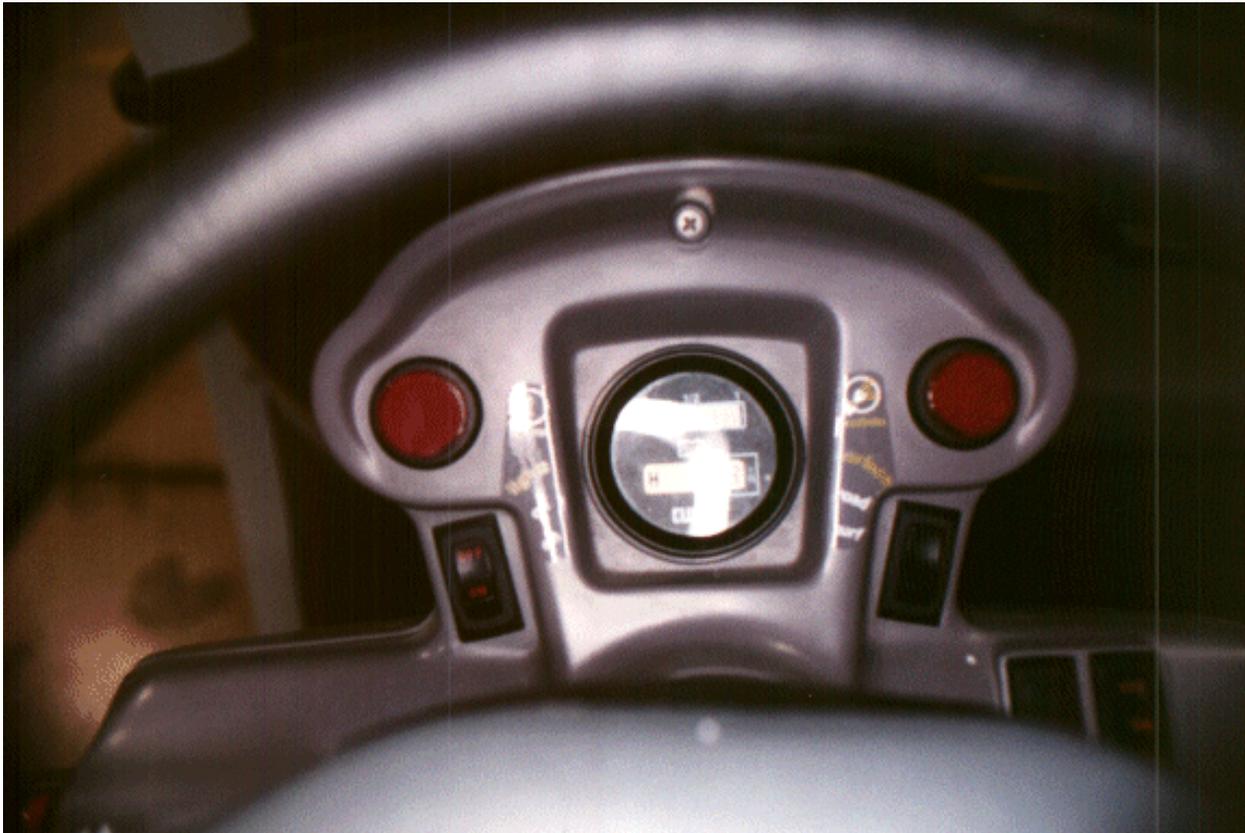
Figure 25 - Control Panel - Center View Through the Steering Wheel

Figure 25 shows the central control panel as seen by the driver. The windshield wiper switch is located at the far right of the picture. The next switch is a non-operative plug. The switch mounted on the right center portion of the panel is the “Road/Turf” switch to select the high (road speed) and low (golf or turf speed) option. The light switch is the left central switch. The gauge located in the center of the control panel had a charge indicator across the top and an odometer across the bottom. The red lens located on the right side of the panel is a seat belt warning light which came on momentarily when the ignition switch was turned to either the FORWARD or REVERSE position. The red lens located to the left of the control panel is labeled Brakes. Since this light did not come on with any position of the parking brake it is assumed that the light was a warning light for the primary brake system. An audible warning buzzer was activated if the ignition switch was turned to the OFF position without engaging the hand brake.

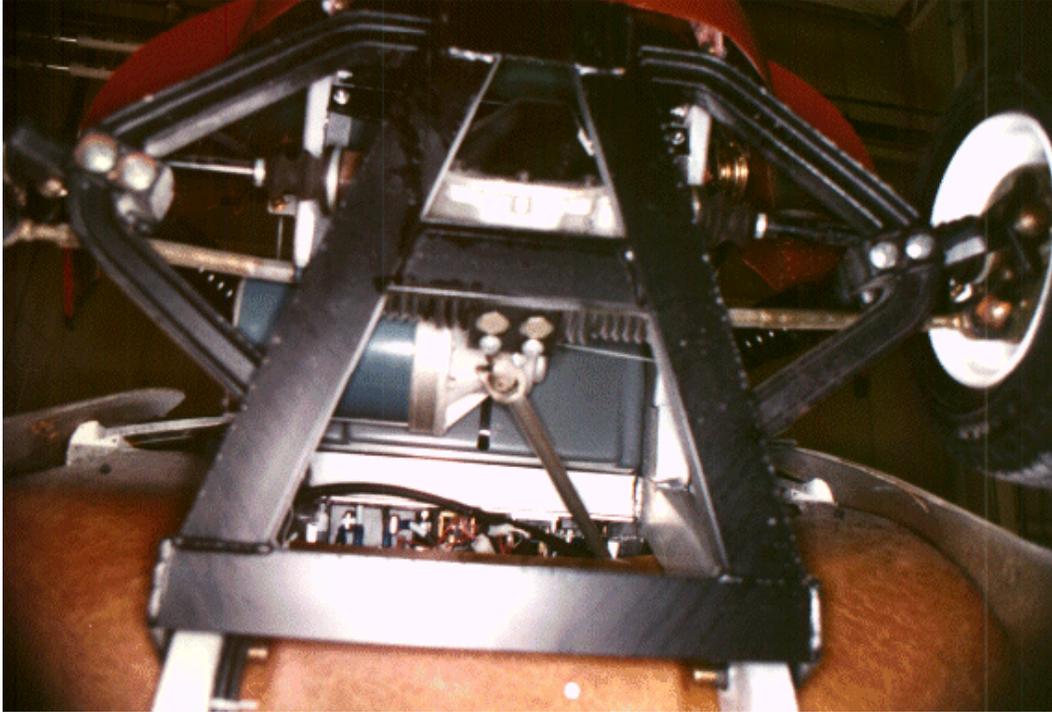
Figure 26 - Front Suspension as Seen From Beneath the Vehicle

The GEM was a front wheel drive vehicle. The forward suspension system must accommodate both the drive system and the steering system. As a result the front suspension system appeared to be relatively complex. Figure 26 is a photograph taken beneath the vehicle showing the A-Arms, electric motor and forward framework of the vehicle.

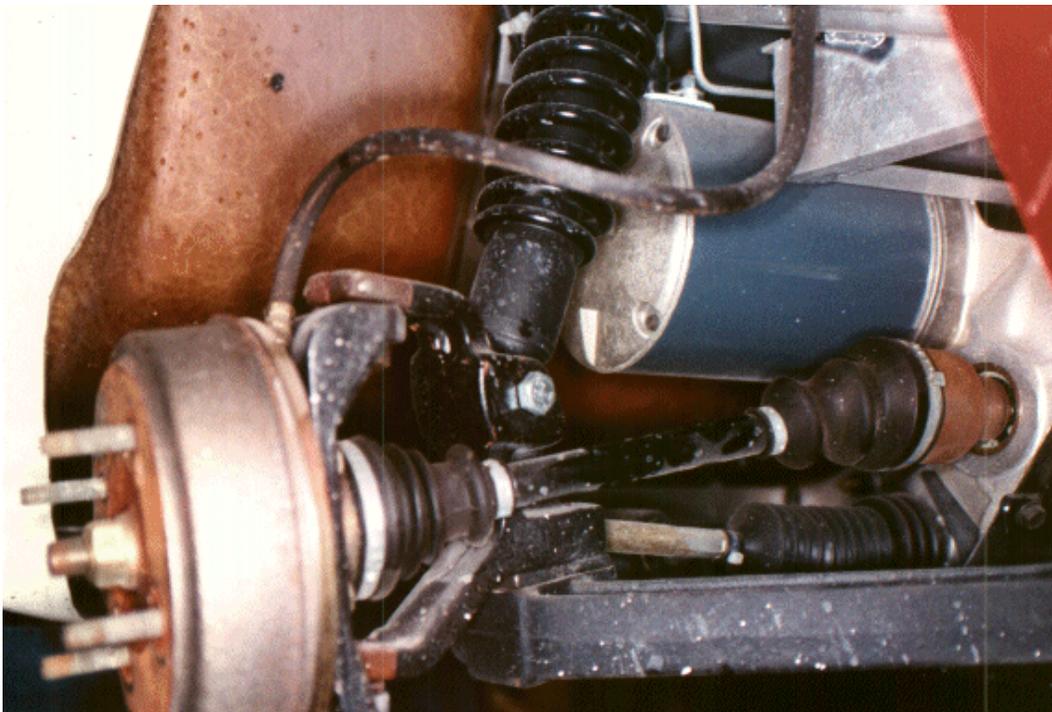
Figure 27 - Details of Front Suspension, Drive Train, and Steering Linkage

Figure 27 shows the details of the front axle and suspension system. The suspension was a shock within a coil spring system similar to that seen on the Bombardier. The lower anchor point for the shock is visible in this figure. The electric motor and part of the transmission are also visible along with the CV drive shaft/axle and the steering linkage. The axle mounting was a split king pin arrangement common in drive axles.

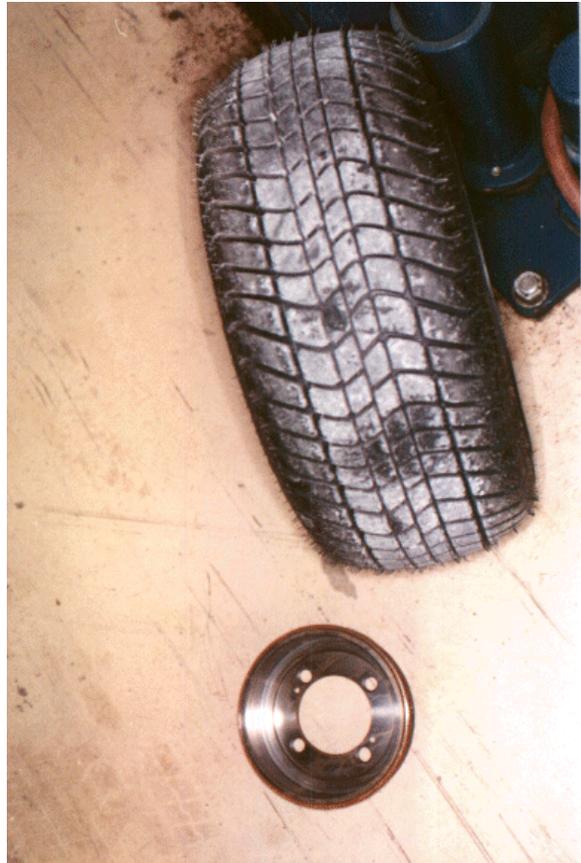
Figure 31 - Goodyear Double Eagle Tire and Brake Drum Used on GEM.

Figure 31 is a photograph of the left rear tire showing the tread pattern.

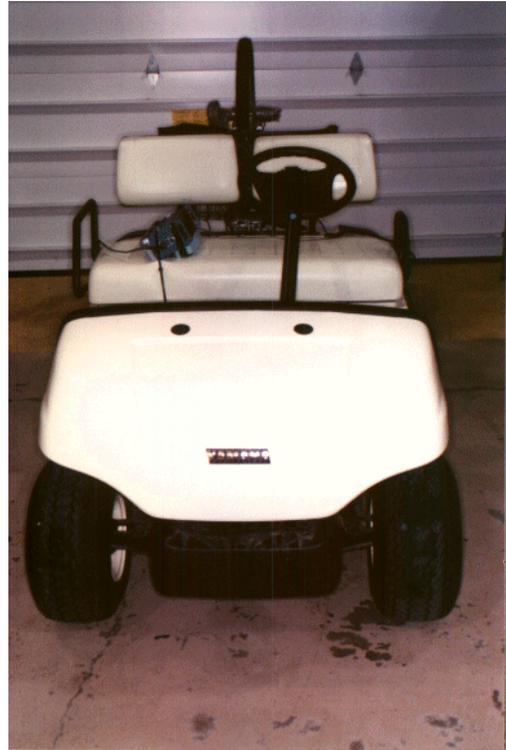
Figure 33 - Front View of Yamaha Golf Cart

A frontal view of the seating arrangement of the Yamaha can be seen in Figure 34. The height of the seat pan of the vehicle was 23.75 inches. The vehicle was outfitted with a single bench seat which had no provisions for adjustment. The seat pad itself was approximately 5.5 to 6.0 inches thick, therefore the height to the top of the seat was about 29.5 inches. There were separate back rests for the driver and the passenger, which can be seen in Figure 33.

The front bumper of this vehicle was a substantial block of formed plastic, approximately six inches thick, attached directly to the heavy tubular framework of the cart. As can be seen in Figure 33, the bumper did not extend across the entire front of the vehicle to protect the tires or fenders.

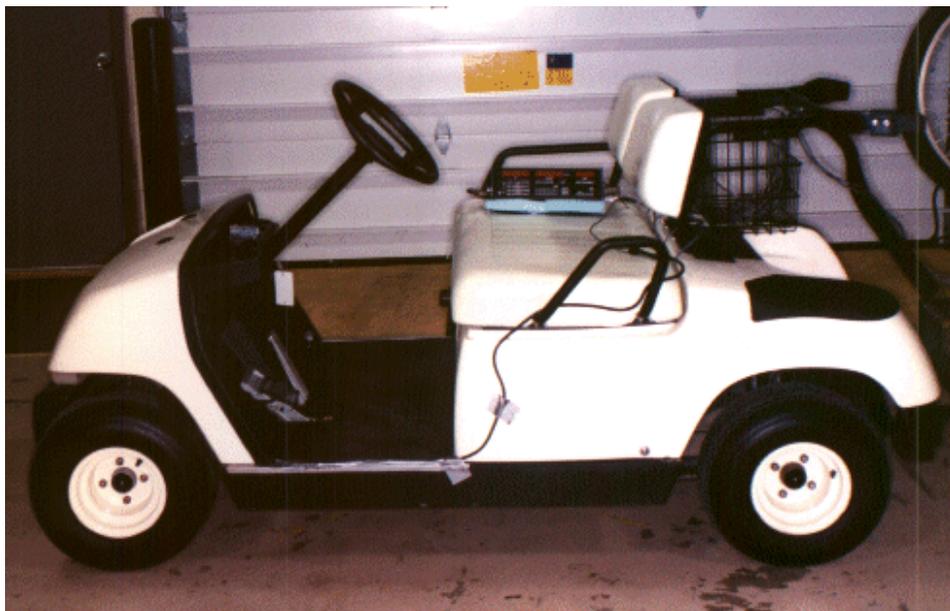
Figure 34 - Side View of Yamaha Golf Cart

The steel tubular side rails on either end of the seats can be seen in Figure 34. These rails were the lateral restraint features that are the industry standard on golf carts. The rails extended from the seat back forward, with the driver side rail measuring 4.5 inches above the seat cushion and extended forward 7.0 inches from the seat back. The passenger side rail was 6.5 inches above the seat cushion and extended 15.0 inches forward of the seat back (approximately the full width of the bench seat).

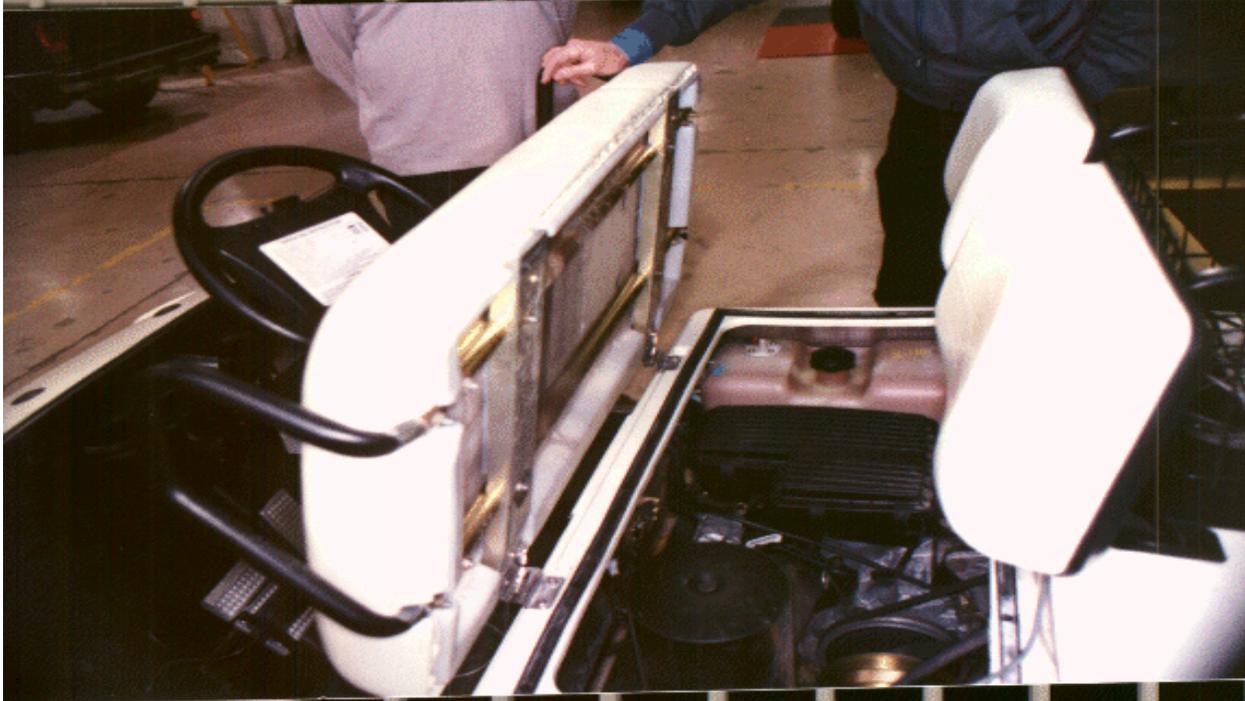
Figure 36 - Bench Seat and Engine Compartment

The battery, and motor for the system was located beneath the bench seat in the engine compartment of the vehicle. As can be seen in Figure 36, the front edge of the seat cushion was hinged to the body of the vehicle and the rear of the bench lifted up to access the engine compartment. Figure 37 is a photograph of the right side of the engine compartment showing the fuel tank, and the cover for the air filter (seen in the center). Figure 38 is a photograph of the left side of the engine compartment showing the sealed, maintenance free battery (on the left), the clutch, exhaust manifold and muffler (center) and the top of the engine and air filter cover (on the right).

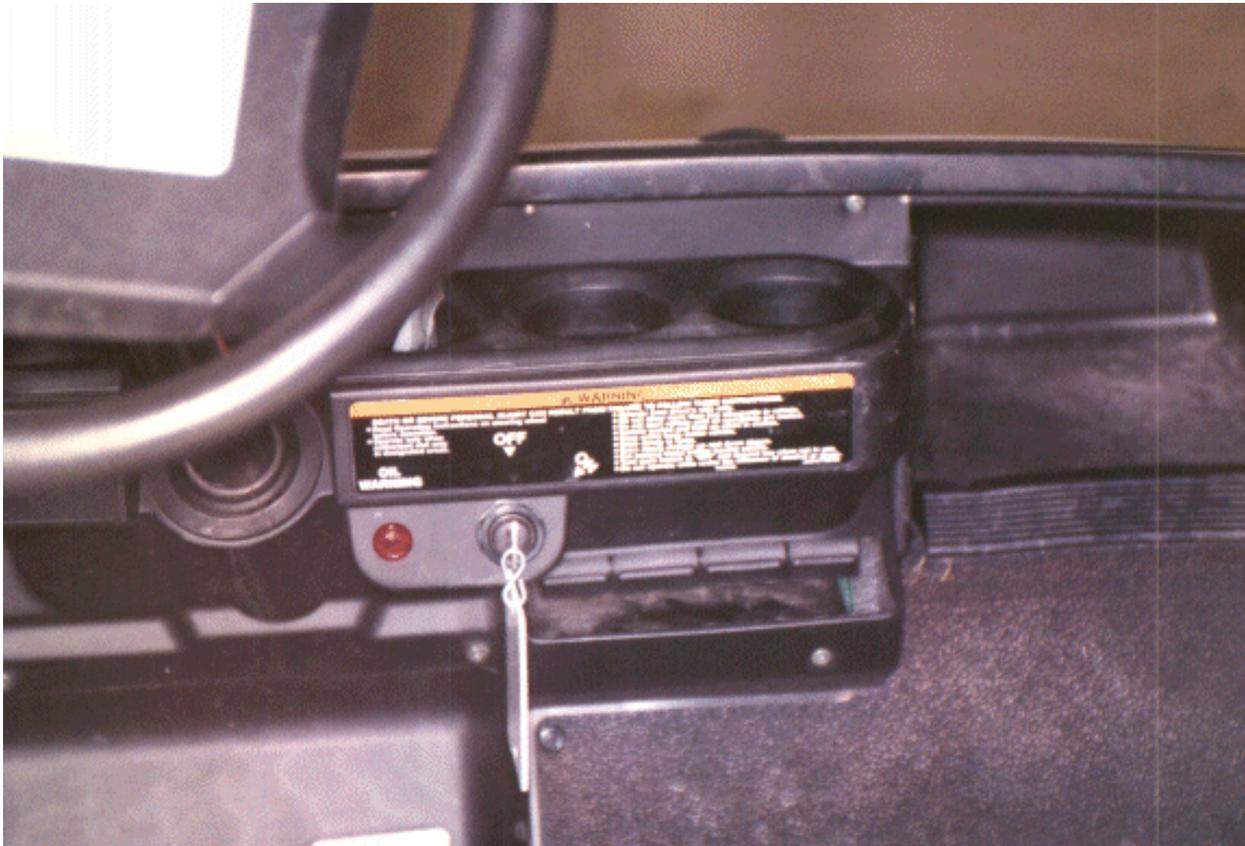
Figure 39 - Keyed Ignition Control Panel With Oil Pressure Warning Light

The vehicle used a keyed system mounted on the dashboard to allow the starter for the motor to be engaged. Figure 39 is a photograph of the ignition lock switch with the ON and OFF positions and operating instructions illustrated. The only other instrumentation was a low oil pressure warning light located to the left of the switch. The starter was engaged by turning the ignition switch to the ON position and stepping on (depressing) the foot operated throttle control. This started the engine and, when a sufficient engine rpm was reached, engaged the clutch. When the throttle control was released, the motor automatically shut off and the clutch decoupled from the drive train.

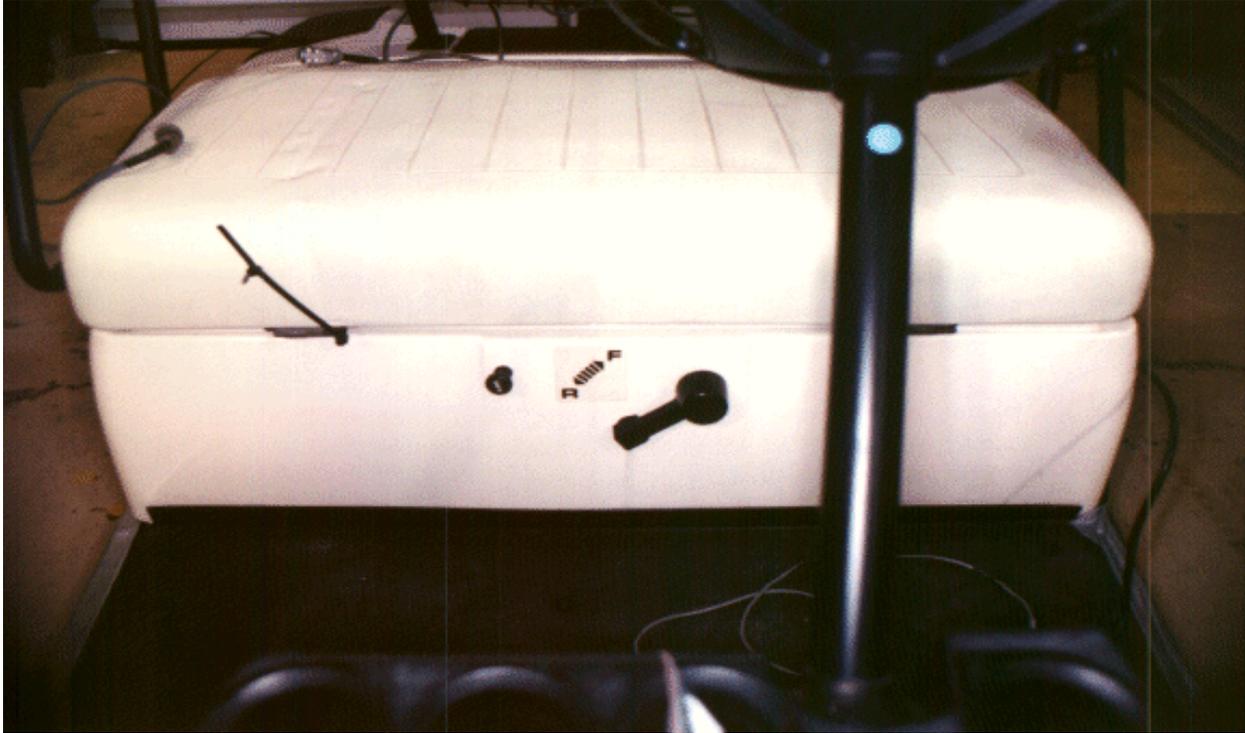
Figure 40 - Front of Bench Seat Showing Transmission Selection Lever and Choke

The transmission selection lever, shown in Figure 40, was located against the front edge of the seat bench between the two occupants. There were two transmission positions marked FORWARD and REVERSE. Turning the lever to the REVERSE position activated a loud piercing

audible beeping signal. The only other control feature was a cold start chock pull knob located next to the transmission selection lever.

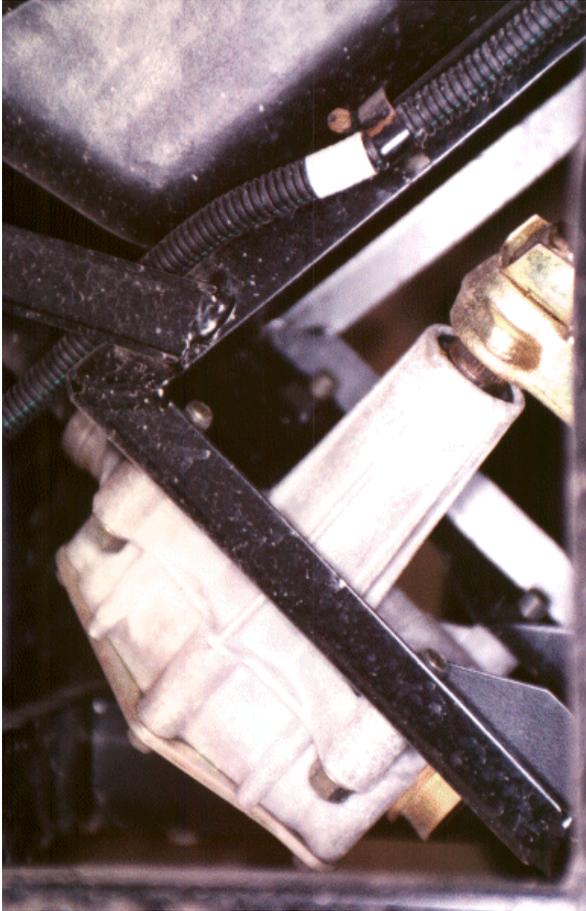
Figure 41 - Yamaha Steering Box

The steering system was a worm and pin system. The steering box (containing the gearing system) is shown in Figure 41, and like the other vehicles examined in this survey, there was no power assistance. There was no apparent damping system in the control linkages to the front wheels. The steering wheel was 14 inches in diameter and had a listed steering angle of 1.5 revolutions counterclockwise (left hand) and 1.5 turn clockwise (right hand). The measured angle was 3.1 revolutions (540 clockwise - 580 counter clockwise. from the center position) from stop to stop.

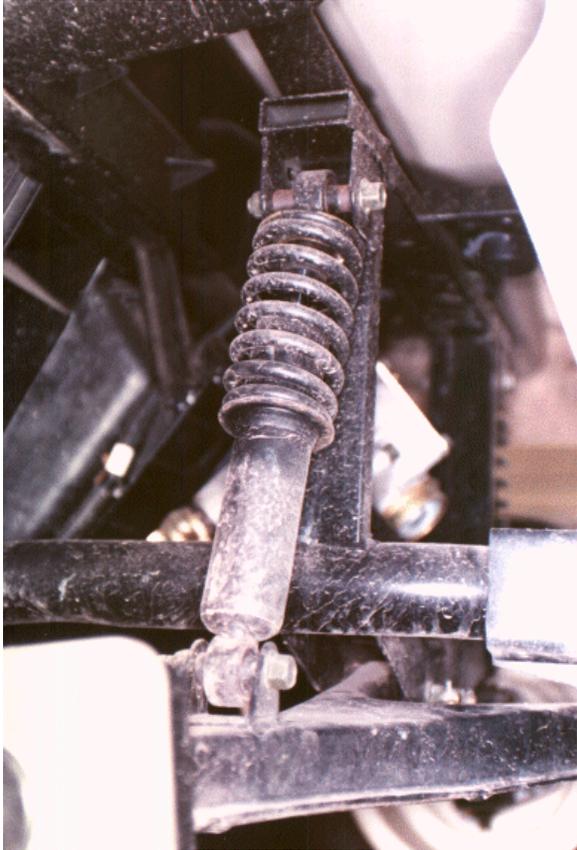
Figure 44 - Front Suspension Anchor Points

Figure 44 shows the upper end of the shock absorber unit along with its anchor point. The flat bar stock seen in the photograph provided a framework to attach the upper anchor of the suspension system and was welded to the main tubular framework.

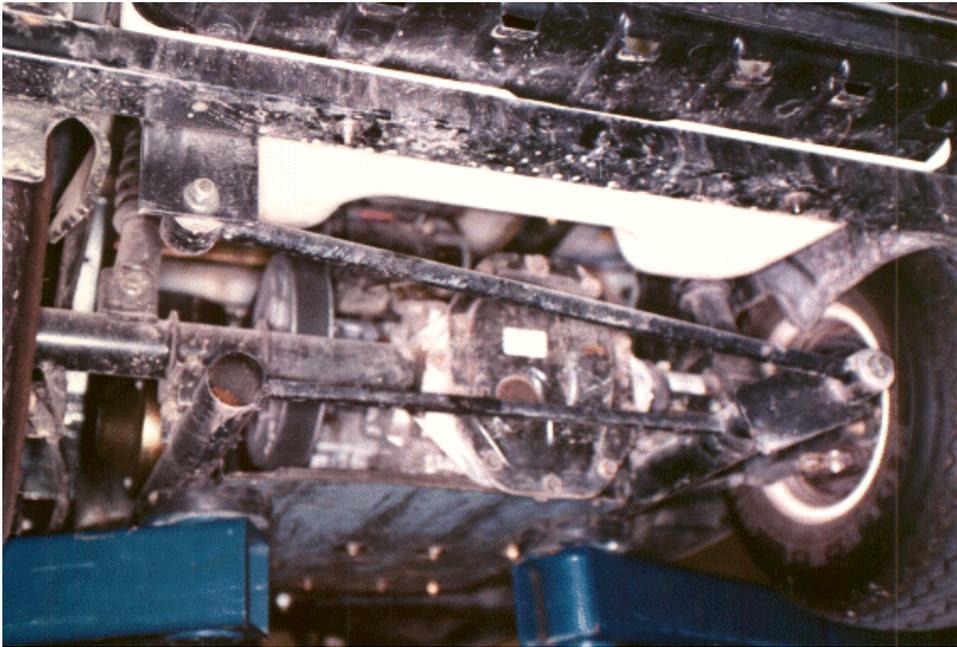
Figure 46 - Rear Suspension - Showing the Transfer Bar

The rear wheels of the Yamaha were attached to a single solid axle. Each rear wheel was equipped with a shock within a coil suspension unit like the front wheels of the vehicle. The vehicle was also equipped with a Panhard or transfer bar. A bar of this type is typically to used reduce sway (side to side or lateral shifting motion) and to control the roll center (generally the height of the roll axis) of the vehicle. Figure 46 is a photograph of this structure.

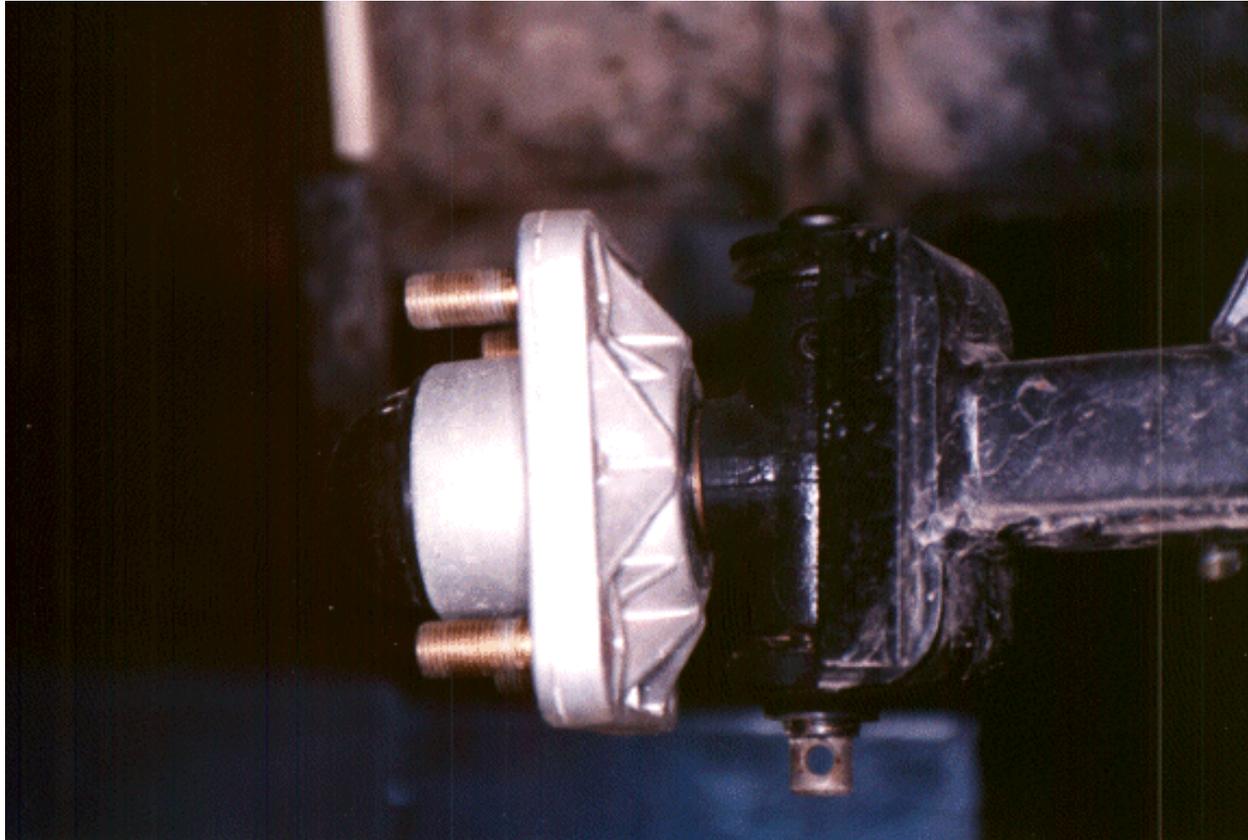
Figure 47 - Wheel Hub With King Pin

The front wheels were mounted to the axles with a king pin arrangement (as compared to a ball joint type of design). Figure 47 is a photograph of the king pin on the front right wheel assembly.

The front and rear hubs (see Figure 47) were to be sealed units. No attempt was made to disassemble these hub units.

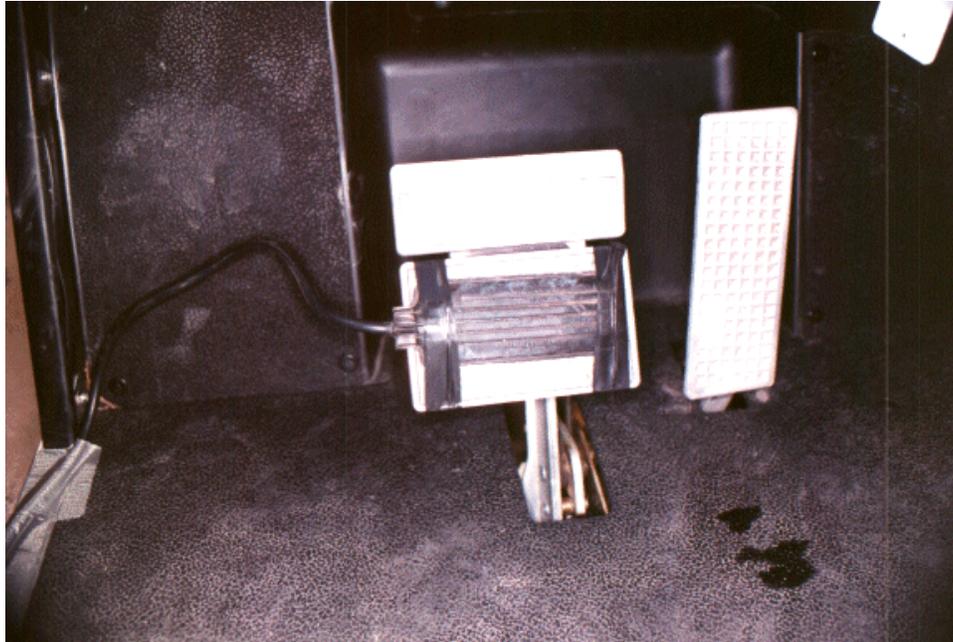
Figure 48 - Foot Controls - Parking Brake Pedal, Brake Pedal, and Accelerator Pedal

The parking brake was a foot actuated brake with an automatic release. Figure 48 is a photograph of the foot controls. The brake pedal, seen on the left, is instrumented with a foot switch

for the dynamic tests. The pedal was comprised of two plates. The lower plate actuated the brake system while the upper (narrow plate) set the parking brake. This parking brake could be released by depressing the throttle control. Figure 49 is a photograph of the operating instructions for the braking system as well as a warning that the vehicle is not intended for use on public streets.

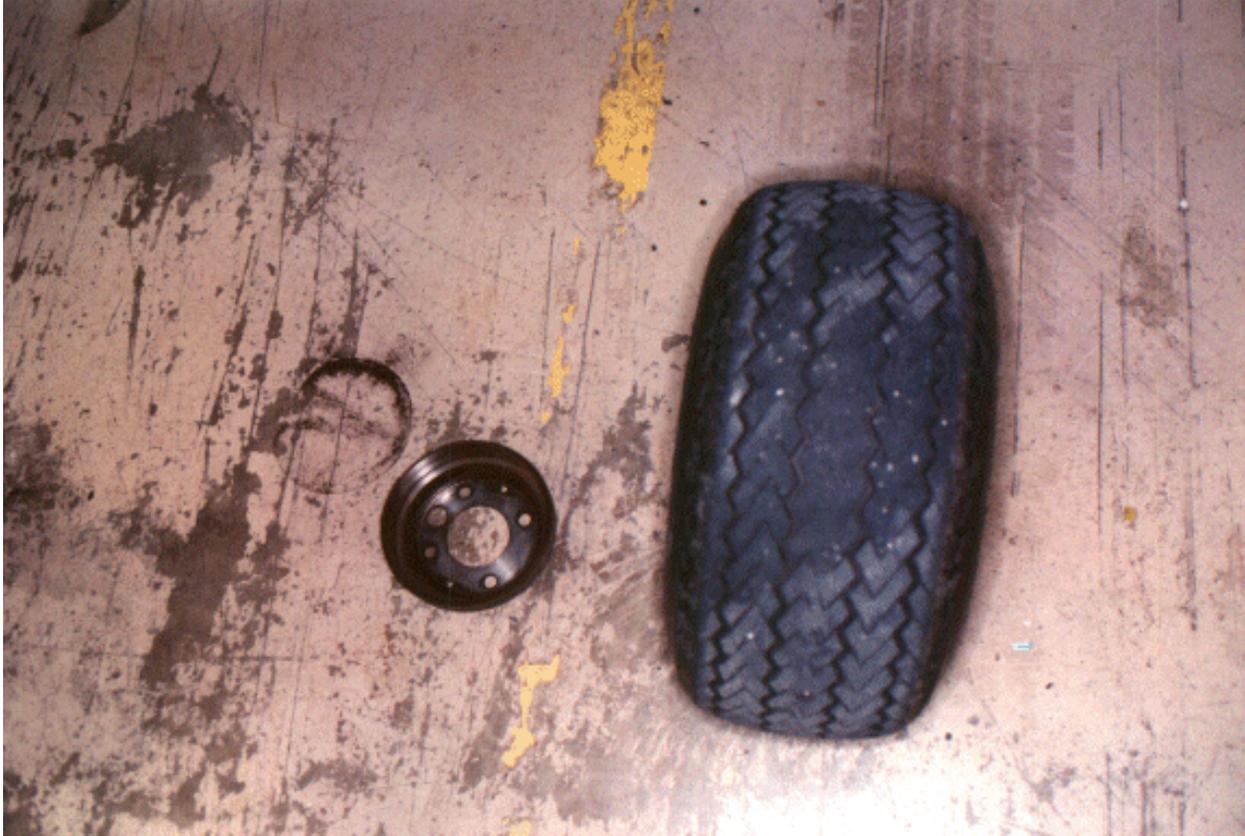
Figure 50 - Turf Tire With Tread Design and Brake Drum

The recommended tire pressure, as listed in the driver’s manual, for the gasoline model was 16 psi (versus 20 psi for the electric model). Figure 50 is a photograph of the tire and tread design.

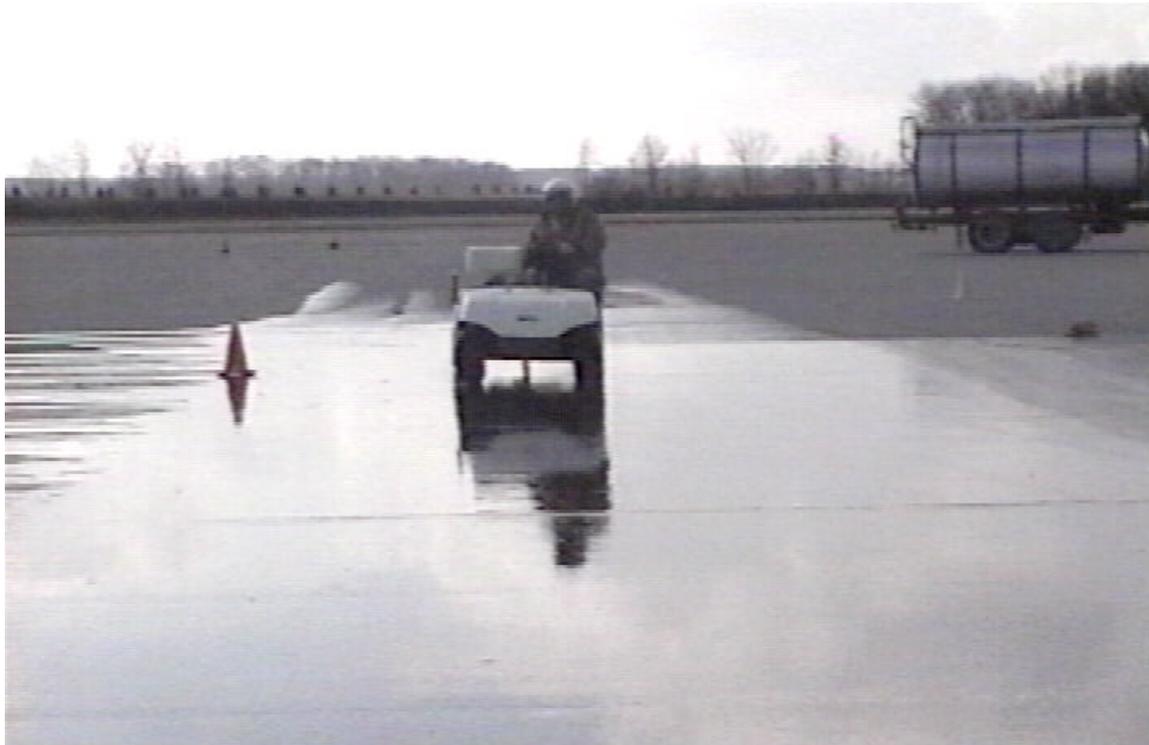
Figure 51 - Jennite Brake Test - Initiation of Brake Test

The brake lockup tests and best effort braking maneuvers on the Jennite surface resulted in some degree of spin in all of the tests conducted. This degree of instability was small and did not present any control problems for the driver at the speeds the vehicle was capable of obtaining. For these tests, lockup of the rear wheels was maintained while the driver used moderate steering efforts to maintain vehicle control (i.e., to steer out of the spin). Figures 51 and 52 are frames obtained from the video documentation of the Jennite surface brake tests. The first frame is at the beginning of the braking sequence while the second frame shows the vehicle at a stop at the end of the brake test. As can be seen in these images, the degree of spin was very small. Again, the comments of the driver for these tests indicated that while some out of line movement did occur, the vehicle always felt stable and controllable.
